PRINCE GEORGE'S COUNTY  
HISTORIC SITE SUMMARY SHEET

Survey #: P.G. #68-33 Building Date: ca. 1899

Building Name: Buck-Catterton House

Location: 4211 Farragut Street, Hyattsville, Maryland

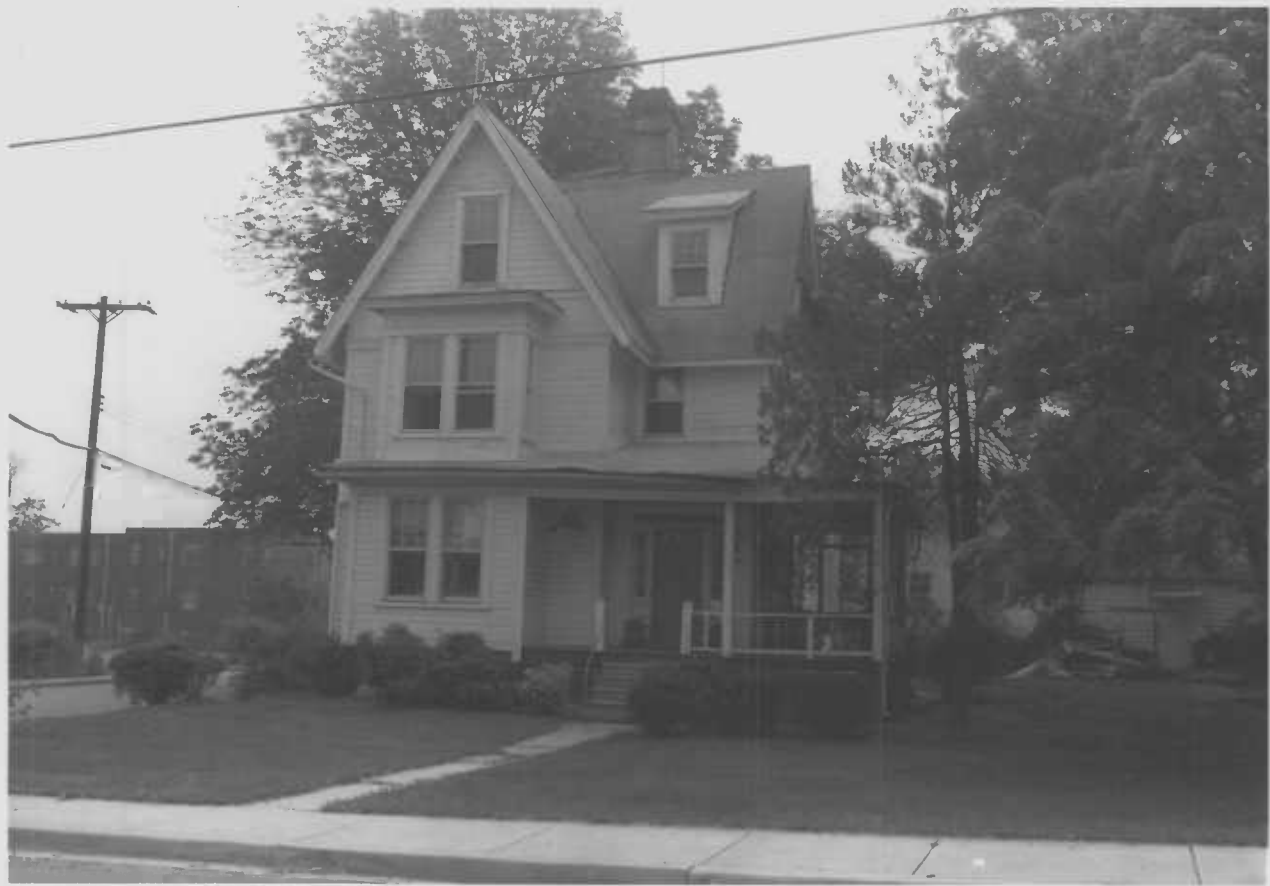
P.G. #68-33

Buck-Catterton House  
Prince George's County, Maryland  
Susan G. Pearl  
May 1987  
North elevation  
Neg: Maryland Historical Trust  
Annapolis, MD

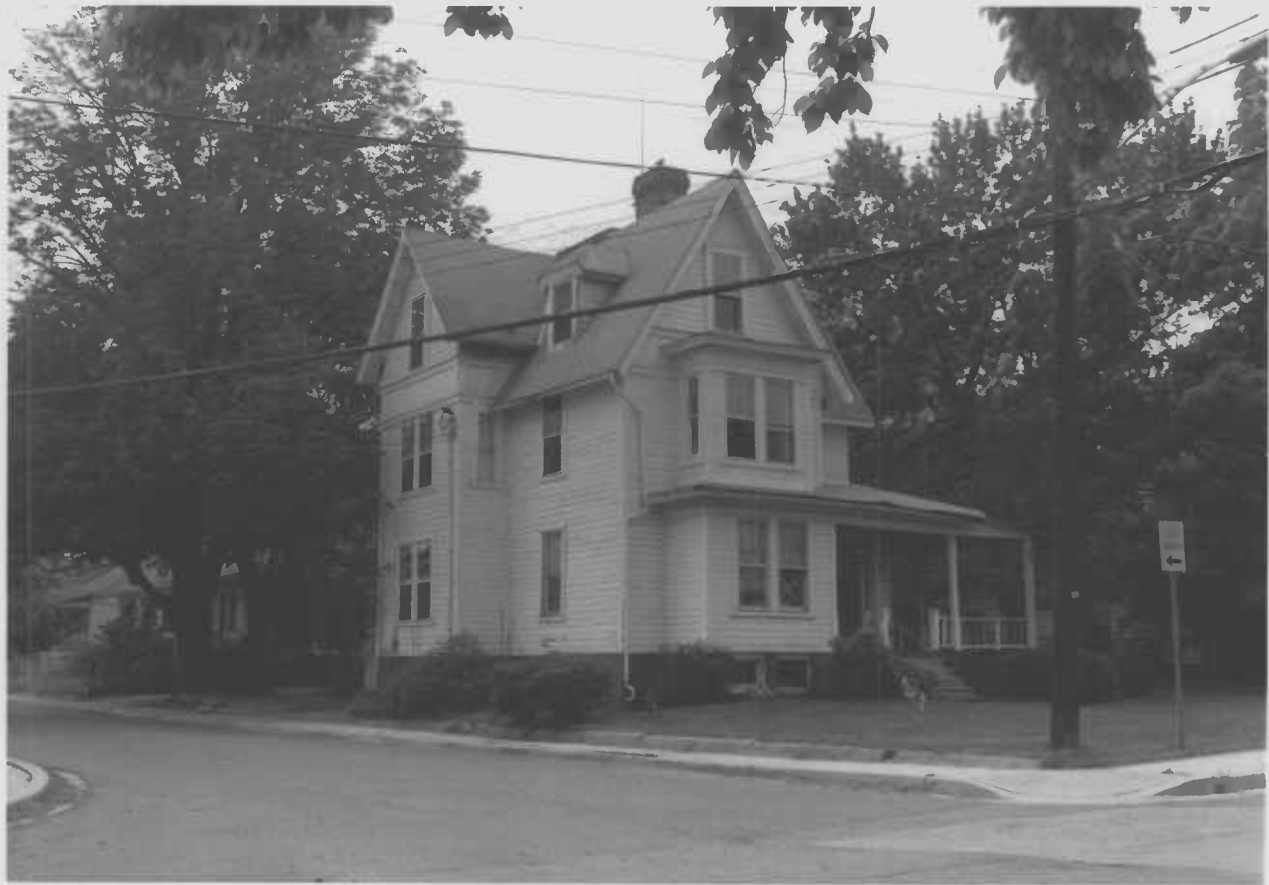
P.G. #68-33

Buck-Catterton House  
Prince George's County, Maryland  
Susan G. Pearl  
May 1987  
Northeast 3/4 elevation  
Neg: Maryland Historical Trust  
Annapolis, MD

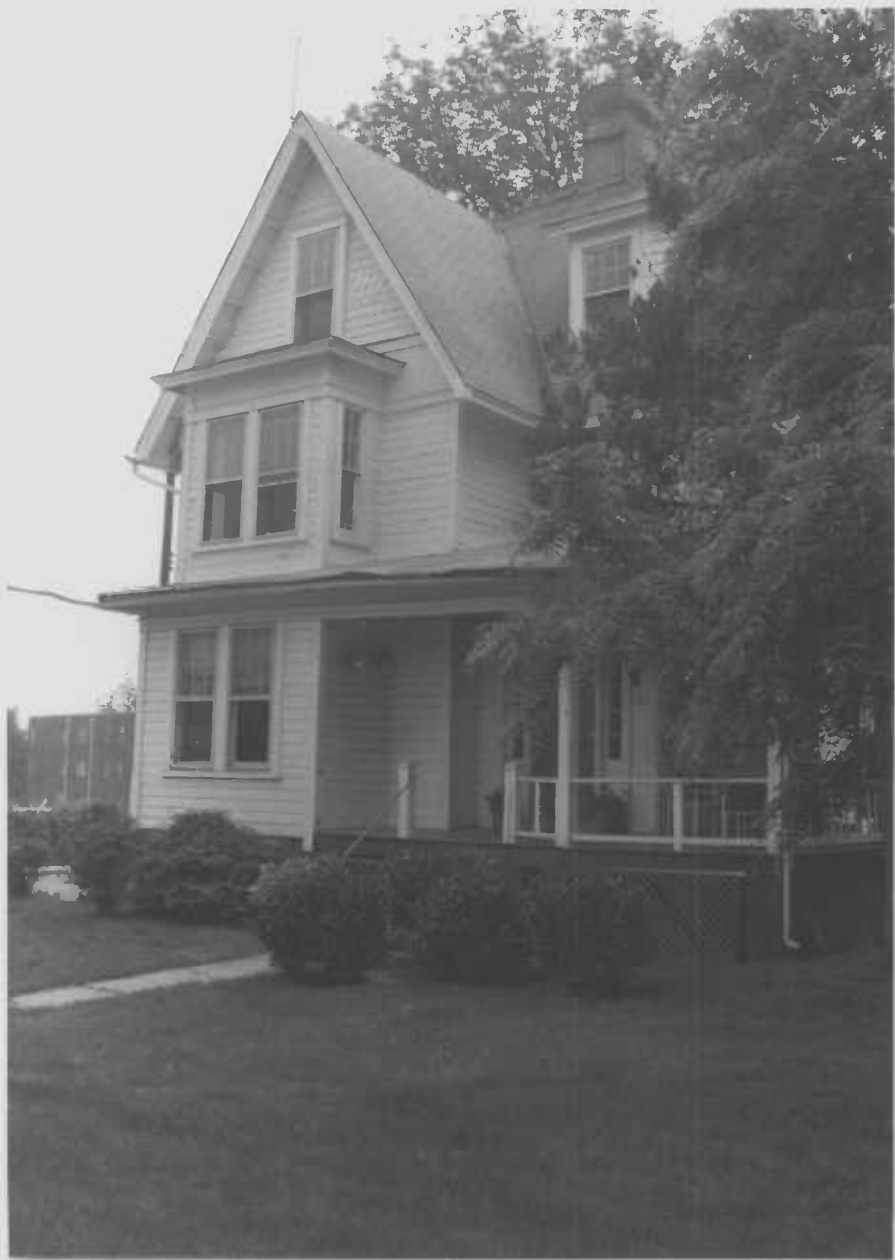
P.G. #68-33

Buck-Catterton House  
Prince George's County, Maryland  
Susan G. Pearl  
May 1987  
Northwest 3/4 elevation  
Neg: Maryland Historical Trust  
Annapolis, MD
